April 21, 2002
**Erosion Damage Thresholds
in North Carolina**

by Spencer M. Rogers Jr.
North Carolina Sea Grant

**COASTAL STORM DAMAGE
REDUCTION PROJECT
SURF CITY AND NORTH TOPSAIL BEACH
NORTH CAROLINA**

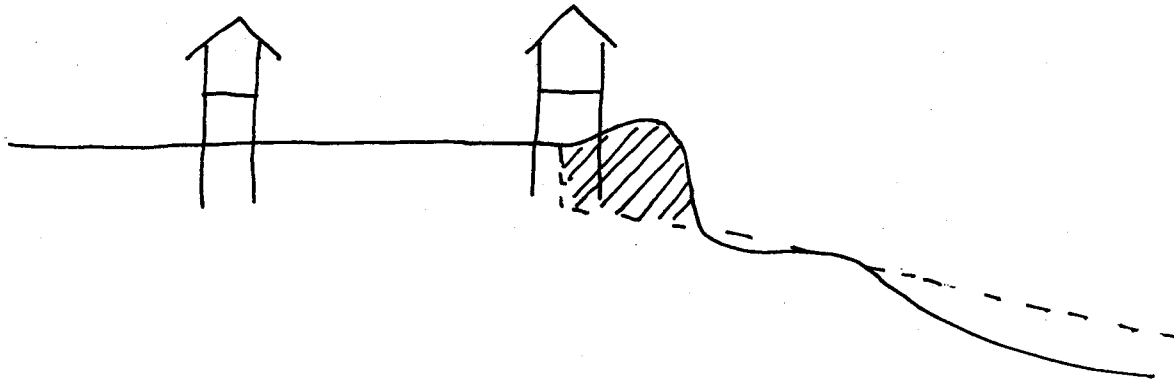
Figure 1: SHORELINE TYPES

- A.** High dune, no overtopping
1. Erosion zone with waves and flooding
 2. High ground (no erosion, waves or flooding)

On ocean shorelines, zones of storm damage have been observed that can be separated by ground elevation into two types (Rogers, 1990) shown in **Figure 1**. The high elevation type is defined as sufficiently elevated to prevent wave effects unless subject to erosion (**Figure 1-A**). The seaward of two damage zones is defined by the area subject to erosion. Buildings in the erosion zone are subject to combined damage from erosion, wave impacts and flooding. The high elevation of the more landward zone protects the buildings from erosion, waves and flooding. Both zones are subject to storm winds.

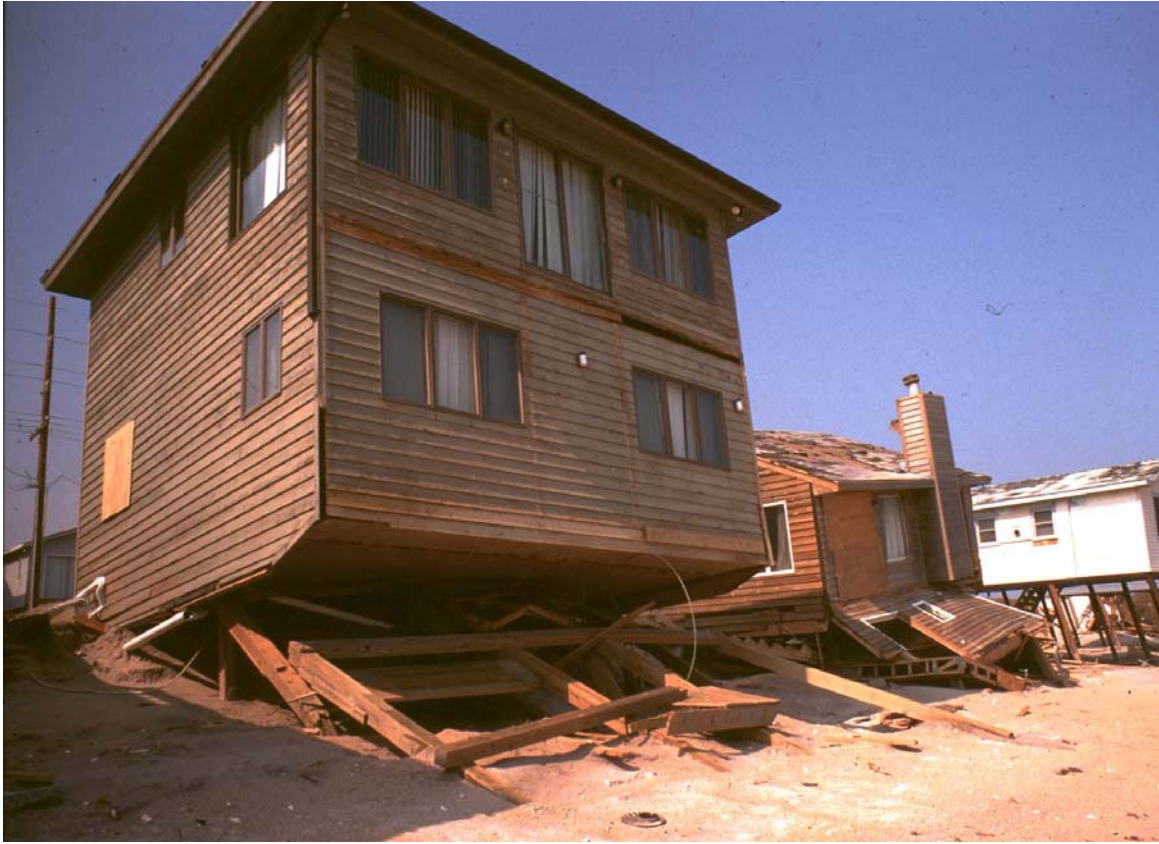
Figure 2: CLASSES OF COASTAL BUILDINGS AND OTHER STRUCTURES

1. Single-family house (includes duplexes & small condos)
 - a. Slab foundation or shallow perimeter footing and interior piers
 - b. Shallow piling foundation (~ 8' below grade: oceanfront, 1965 thru 1985 and farther inland, all dates.)

- c. Deeper piling foundation (piling penetration to -5' NGVD or 16' below grade, whichever is shallower, 1986 and later, oceanfront only)
2. Commercial or large multi-family buildings

- a. Slab or other on-grade foundation
 - b. Second floor and above piling supported, lowest floor on grade (common in hotel and condos)
 - c. Fully piling supported, deep pilings, [some wood-frame, pre-1985 oceanfront condos may have shallow pilings as in 1b above]

- d. Building specific evaluation (fishing piers, etc.)
3. Underhouse enclosures: may be unfinished or finished interior
Unfinished enclosures have fixed cost per either SF or linear wall footage
Finished enclosure valued as ratio of total finished floor area

- a. None (parking slab?)
 - b. Small (<300 SF)
 - c. Partial (>300 SF, < full)
 - d. Full enclosure
4. Mobile homes, utility buildings, detached garages, decks seaward of oceanfront houses, gazebos, pools etc

5. Dune walkways
 - a. Houses
 - b. Public/commercial
6. Paved roads and parking lots
 - a. Damage
 - b. Overwash excavation
 - c. Sand sifting operations
7. Erosion control structures and actions

- a. Beach scraping
 - b. Emergency sandbags

To predict erosion damage within the described zones, it is useful to separate structures into several different classes as shown in **Figure 2**. Buildings are separated by general size, typically single-family houses and larger commercial buildings. Both classes of buildings commonly use breakaway walls and enclosures under piling supported, elevated buildings. The behavior of the enclosures is sufficiently different and often independent of the elevated buildings therefore justifying a separate class and damage calculations for the enclosures. A broad class of structures including mobile homes, swimming pools and other expendable structures, including decks seaward of oceanfront houses, are grouped as highly erosion sensitive structures. Dune walkways, roads and erosion control actions are listed as separate classes. It is useful to separate the buildings and several other classes into subclasses, based on similar construction characteristics. Suggested erosion damage tables for Classes 1-5 are included as an appendix.

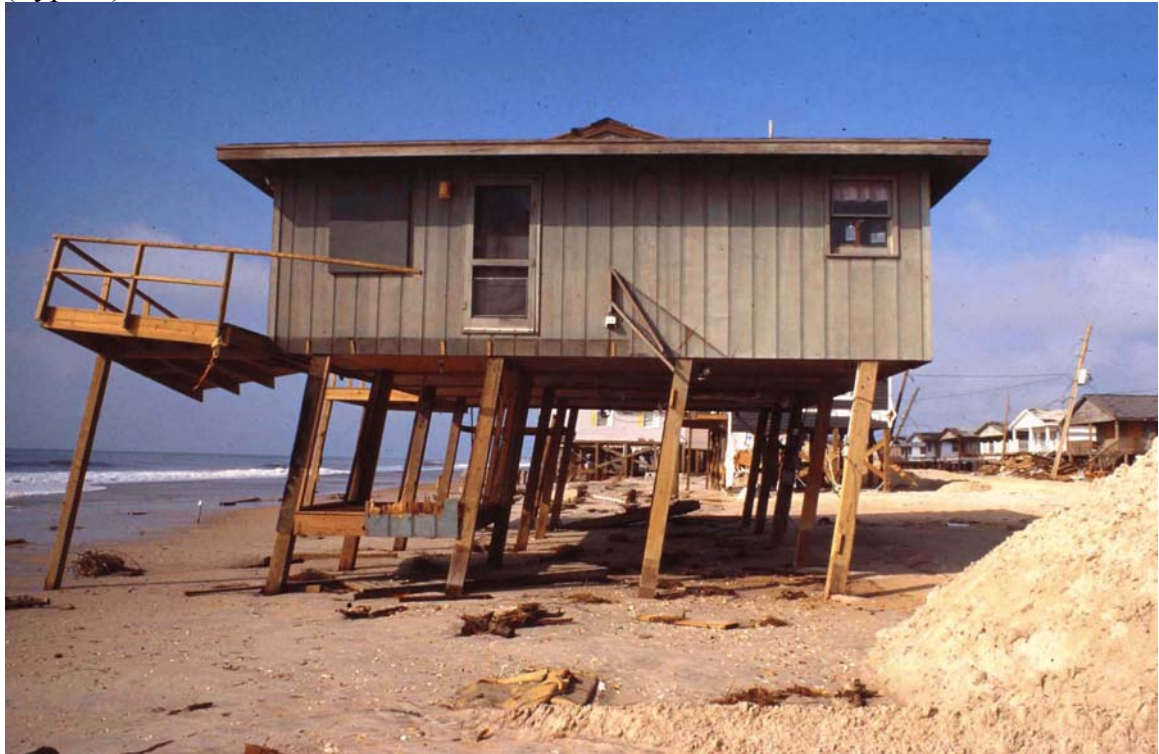
Figure 3: Short piling foundation failures (Class 1b) on high-elevation shoreline (Type A). Location: Kure Beach NC after Hurricane Fran.

The shallow foundations in Class 1a are equally erosion damage prone in both shoreline elevation types. The shallow pilings in Class 1b are ineffective on high elevation, Type A shorelines, and perform like Class 1a (**Figure 3**). At lower ground elevations of Type B a moderate level of erosion resistance is provided (**Figure 4**). For short pilings, +12' NGVD is suggested as an effective ground elevation separation for shoreline type. Shallow piling foundations in Type A shorelines have a piling tip penetration above +4' or slightly above the mean high water elevation, too little embedment to improve the erosion-resistance over Class 1a. Significant damage to deeper imbedded pilings is likely to begin when the erosion depth exceeds 4', half the embedment depth of 8'.

Kure Beach, NC in the vicinity of Avenue E Figure 3

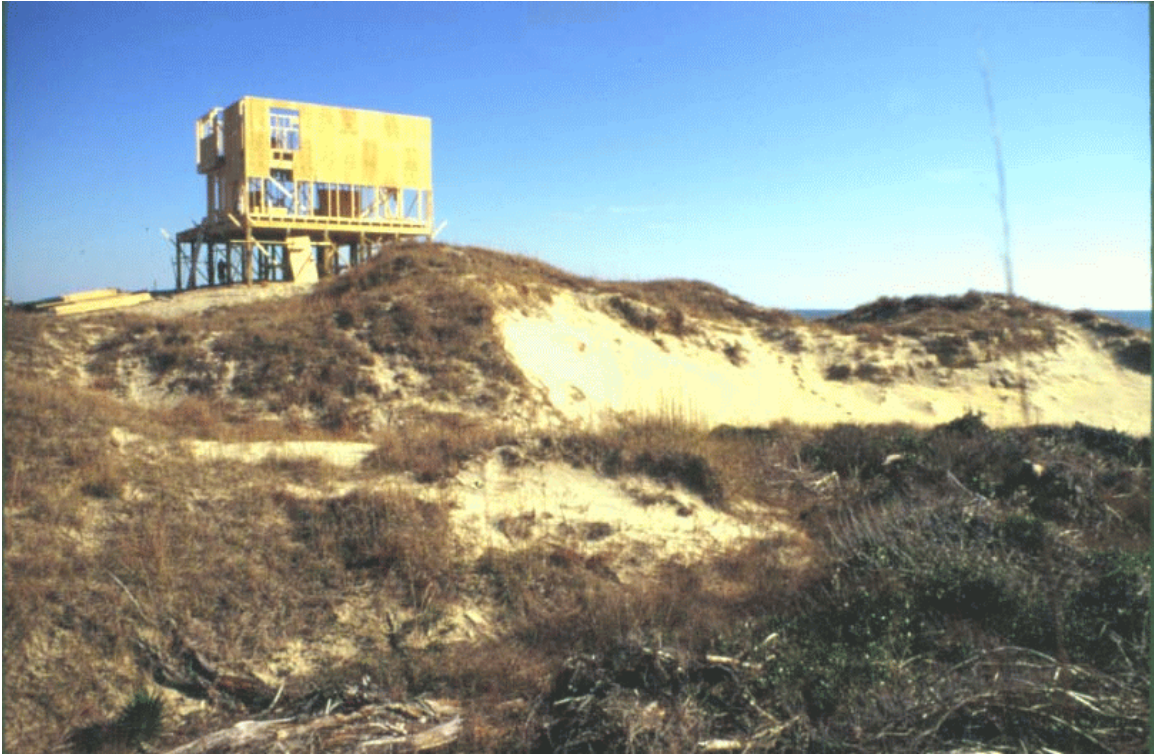
Figure 4: Short piling foundation (Class 1b) near failure on low-elevation shoreline (Type B). Location: Surf City NC after Hurricane Fran.

1226 N. Shore Drive & Jones Avenue, Surf City, NC Figure 4
 Area includes: Severely leaning house on short pilings
 Post-1986 house on long piles, undamaged
 Multiple pre-1986 houses destroyed.

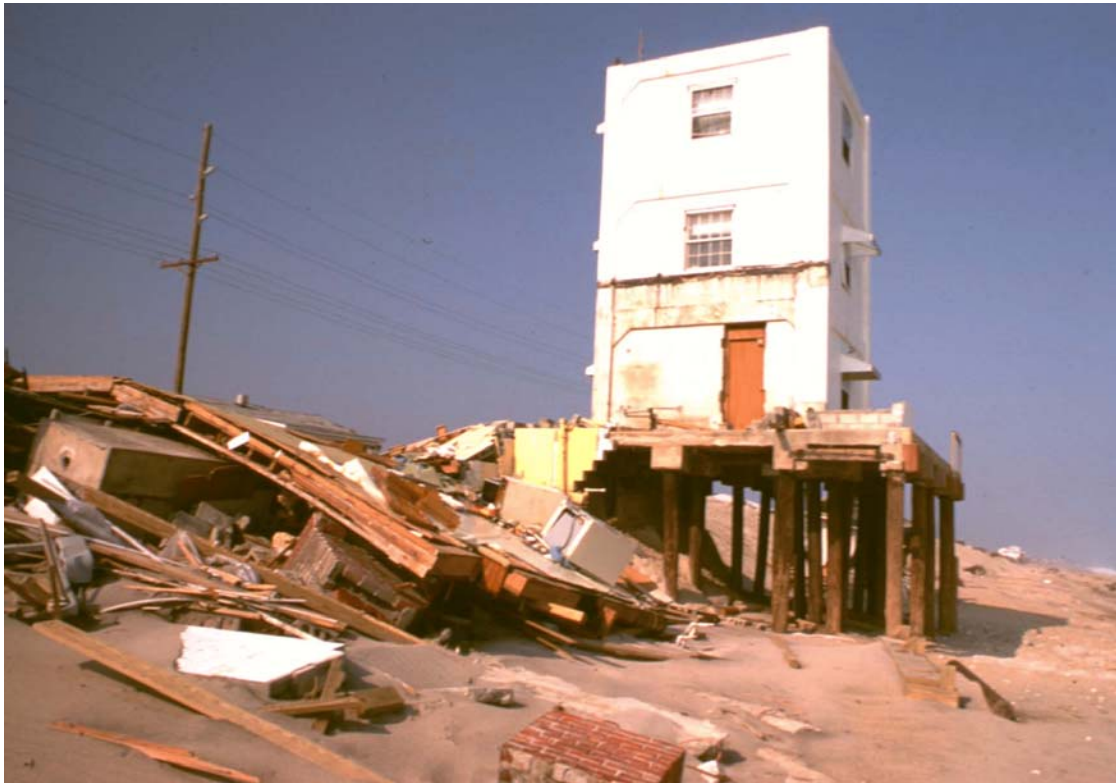
Figure 6: Houses on 1996 pilings (Class 1c) on low-elevation shoreline (Type B). Location: Topsail Island after Hurricane Fran.

On high elevation Type A shorelines the deeper pilings of Class 1c are limited in effectiveness by the 16' feet below grade requirement. The shoreline types can be separated by a ground elevation of +16' NGVD. On A shorelines, the piling embedment will be no deeper than 0.0' NGVD and can be expected to perform similar to the other grossly eroded foundations in 1a and 1b(A) (**Figure 5**). When piling embedment approaches or exceeds the -5' NGVD piling standard on lower ground elevations (Type B) the erosion resistance of 1986 piling standards proved very effective during Hurricane Fran (FEMA, 1997 and Woodward-Clyde, 1997.) See **Figure 6**. An erosion threshold of 4 feet is suggested.

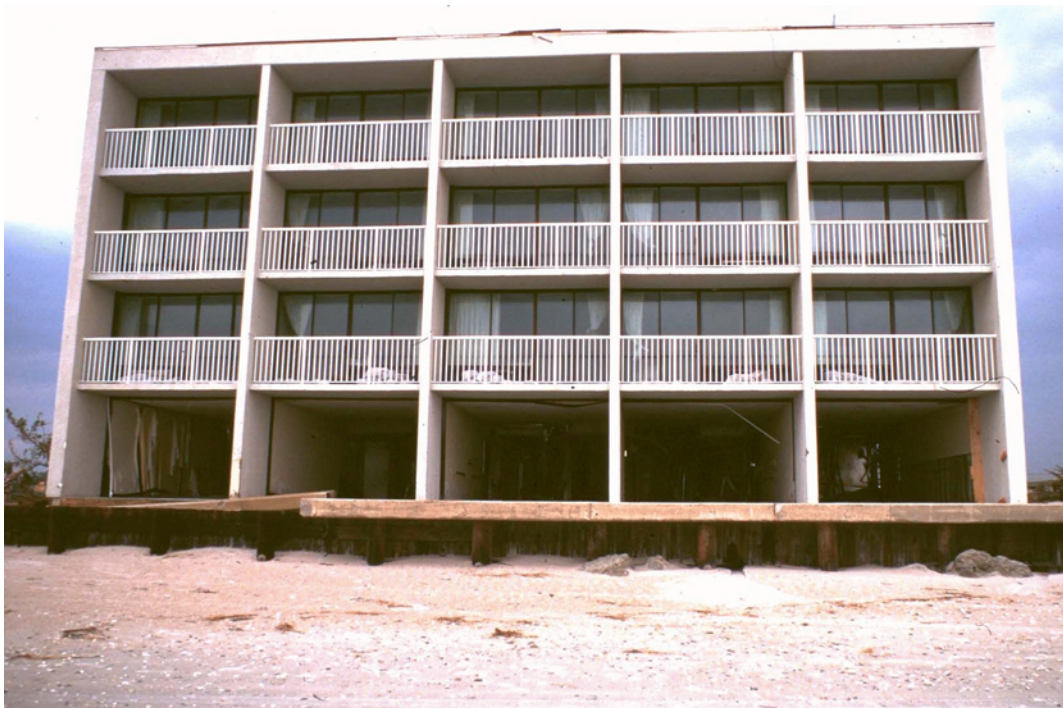
Figure 7: Slab foundation failure (Class 1a & 2a) beside commercial/deep-piling structure (Class 2c) on high-elevation shoreline (Type A). Location: Surf City NC after Hurricane Fran.

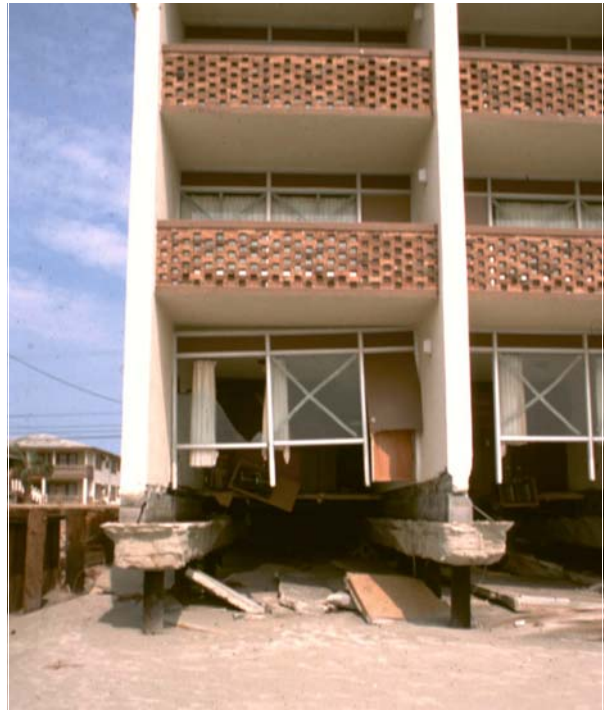
Figure 8: Piling-supported hotel with lower floor on unsupported slab (Class 2b) on low-elevation shoreline (Type B). Location: Wrightsville Beach NC after Hurricane Fran.

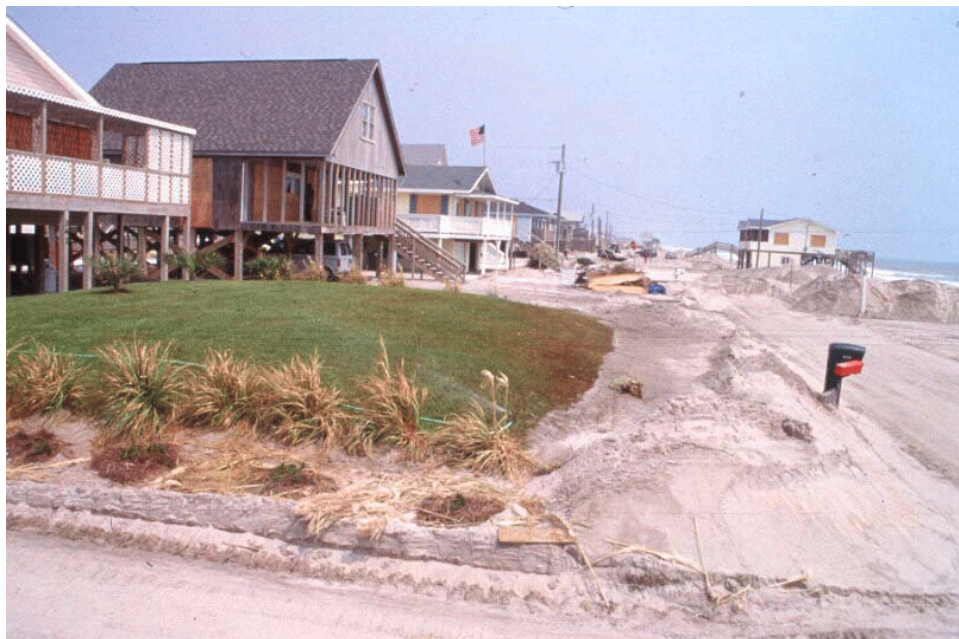
Figure 10: Second-row dune left after Hurricane Fran provided protection during Hurricanes Bonnie, Dennis and Floyd. Location North Topsail Beach after Hurricane Floyd.

341 Topsail Road & 11th Avenue, North Topsail Beach, NC Figure 10
 Second-row house has been protected by overwash
 deposit left in place after Hurricane Fran.
